FANNON, BRIAN R., PhD. Beaver Dam Features Influencing Stream Channel Form in the Mountain and Piedmont Physiographic Provinces of North Carolina (2015)

BEAVER DAM FEATURES INFLUENCING STREAM CHANNEL
FORM IN THE MOUNTAIN AND PIEDMONT
PHYSIOGRAPHIC PROVINCES OF
NORTH CAROLINA

A Dissertation Submitted to
the Faculty of The Graduate School at
The University of North Carolina at Greensboro
in Partial Fulfillment
of the Requirements for the Degree
Doctor of Philosophy

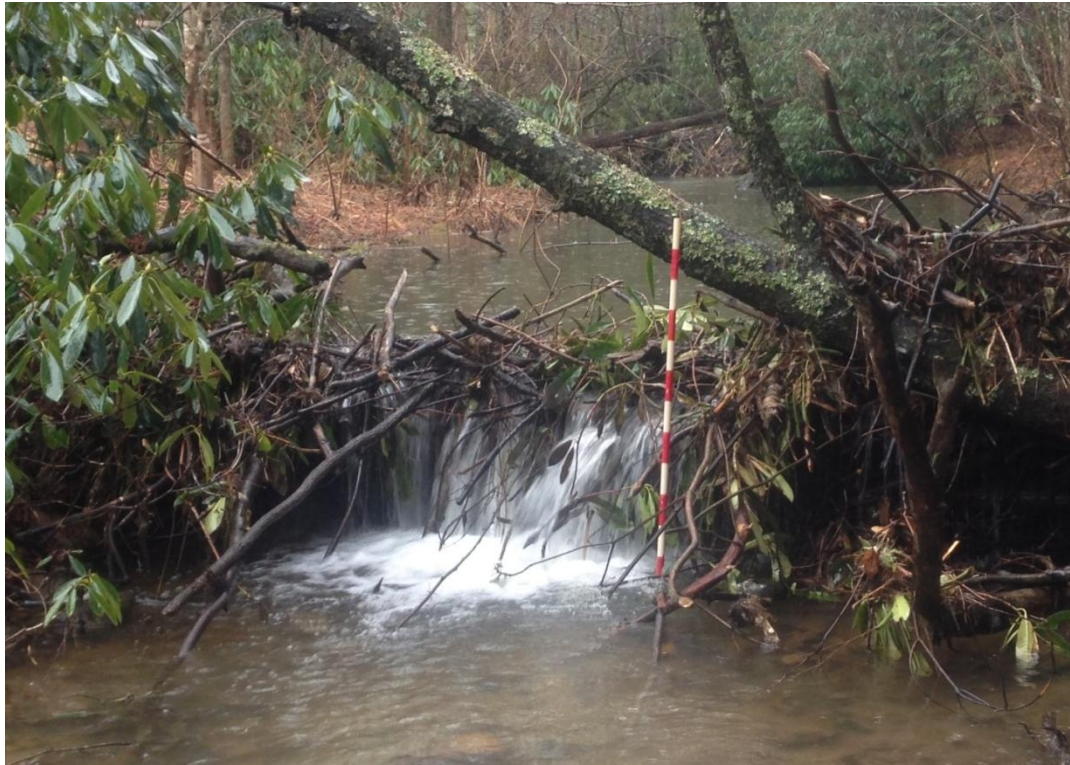
Figure 3. Sticks and Stones Dam. (Author)

as filler in the lattice, as does some courser soil, but in limited amounts. These dams, even when active, typically have multiple outlets due to the unfilled areas of the wooden lattice. During the course of this study this construction proved the most fragile, as all were washed out in less than two years. Two other locations of previous dams of this type were noted and identified through local residents, and in sites M2b, M5, M6, and M7, noticeable stone deposits were left across the streambed after the loss of the woody material. These formation were dispersed after 3-5 months in M2b and M5. Sites M6 and M7 were discovered after the woody components were gone, but the cobble accumulation persisted for over a year after initial discovery. It is not know if the stone accumulation was due primarily to beaver activity or the trapping action of the dam, but likely, the bulk of cobble-sized material was collected through trapping. It is quite possible that the material has both an armoring effect of the stream bottom, and also Manning's coefficient, which raises the possibility that the beaver activity may continue to affect the stream channel for some time after the cessation of activities. This is especially true in instances where beaver have denuded the bank during the active phase, leaving it more vulnerable to stream activity influenced by the remaining cobble.

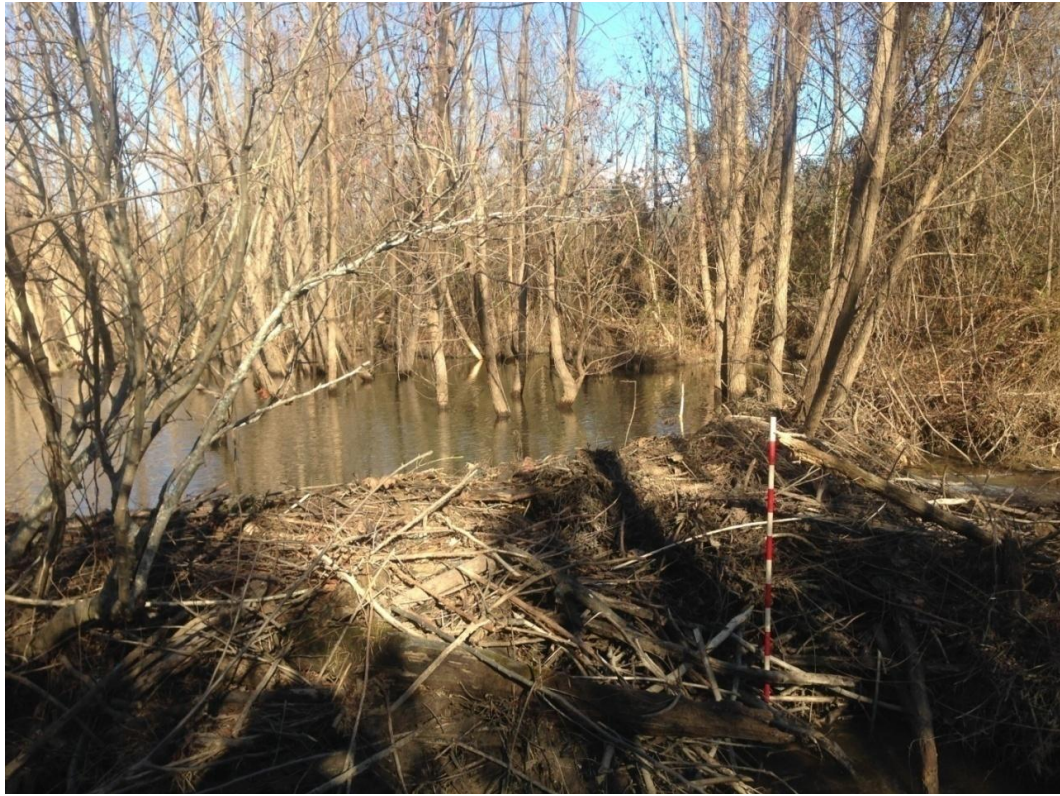
Figure 4. Wattle and Daub Dam. (Author)

Wattle and Daub dams represent the classic idea of a beaver dam, with both woody material and soil. Construction is very similar to early house construction using a wooden lattice (“wattle”) woven closely enough to support soil material (“daub”) applied to it. These dams may also have stones embedded erratically, but they do not form a continuous structural element through the dam. These dams represent a transition in available materials, and are typically found at lower gradients than the sticks and stones dams. These were not noted to form a significant accumulation of cobble, possibly due to lower stream energies at lower grades.

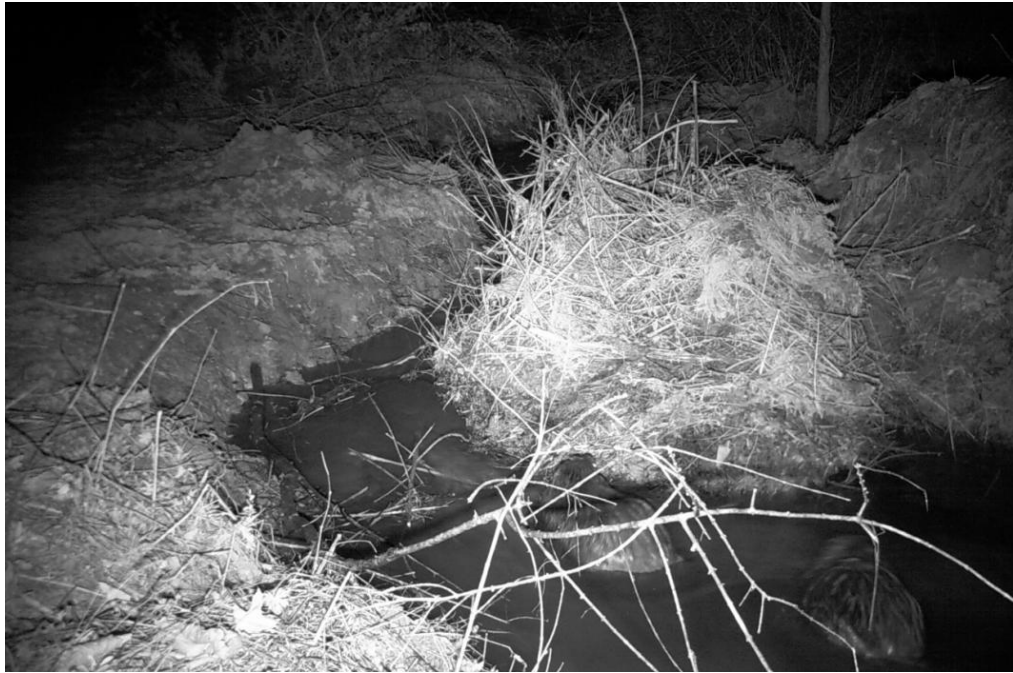
Figure 6. Beaver rebuilding Dam Section, Foundation Section. (Author)

Another experiment at P1a provided documentation that the inclusion of vegetation was not incidental to the packing of soil onto the dam. A 1 meter wide by .5 meter deep breach was introduced into the dam, and an infrared camera trap installed to monitor activity. The progression of rebuilding was photographed, with figure 6 showing initial foundation work of small woody material, figure 7 showing grasses/sedges being added, figure 8 showing wet soil being packed on the structure, and figure 9 showing the finished patch the next morning. Note the lack of any large woody material during the construction process; however, by the next morning several pieces had been pushed over the top onto the downstream face of the repair. These were later covered over by the inclusion of more soil and herbaceous material as the patch was worked on over the next several weeks, but always with the same pattern of woody material being pushed over the dam.

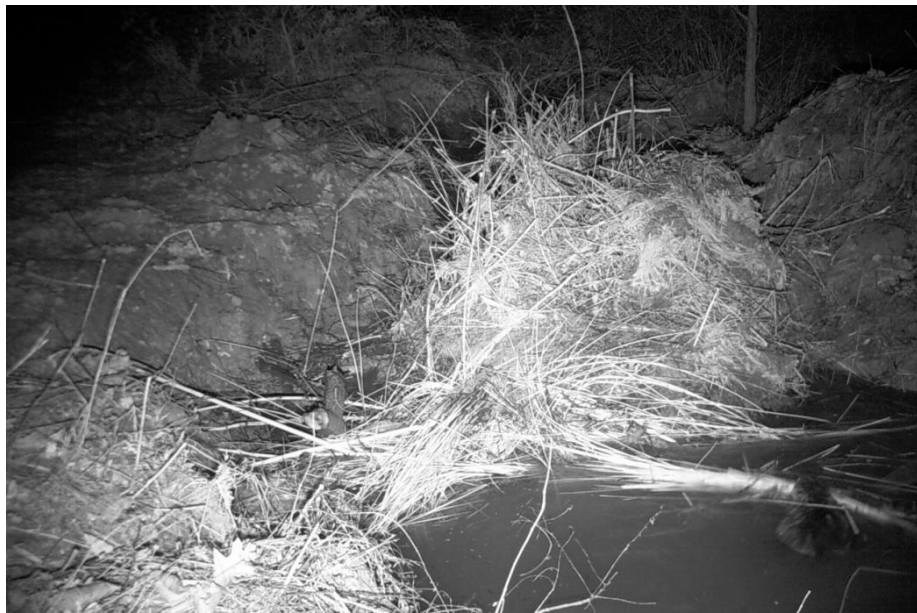
Figure 7. Beaver rebuilding Dam, adding Herbaceous Material. (Author)

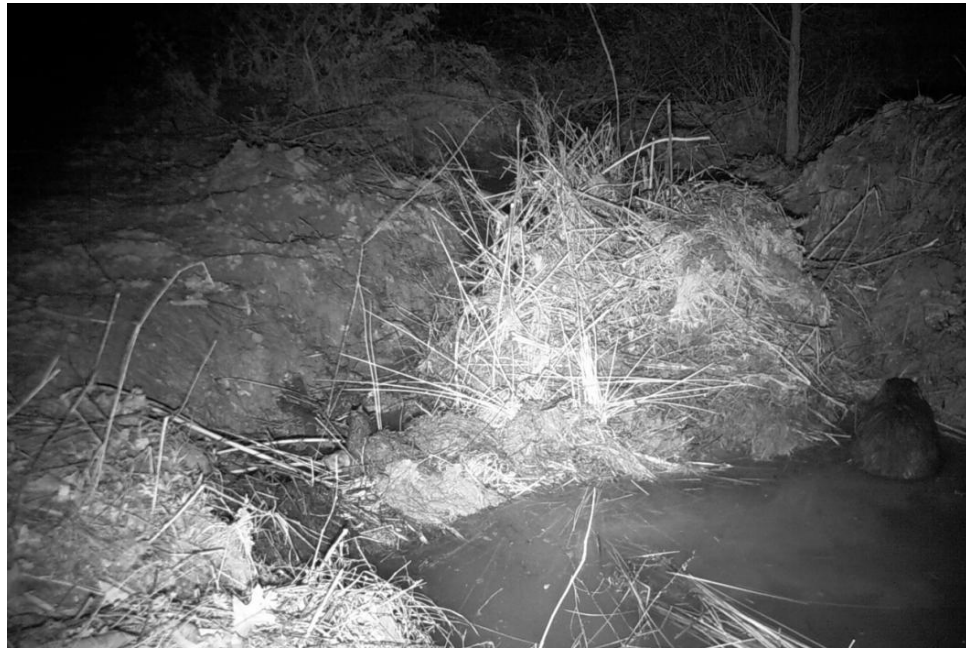
Figure 8. Beaver rebuilding Dam, packing with Soil. (Author)

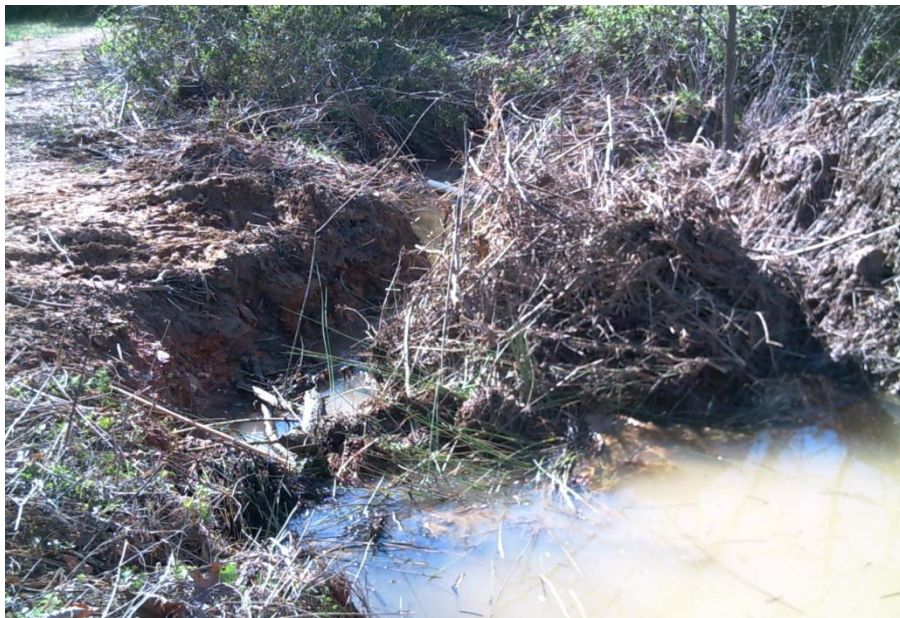
Figure 9. Beaver rebuilding Dam, Finished. (Author)

Although I was not able to document any high flows that overtopped these dams, it is likely that the woody material on the downstream face acts as armor against erosion when water flows over the dam. I did find extensive evidence of leaves, grasses, and small sticks tangled in the wood, apparently as a result of water flowing through the woody matrix.

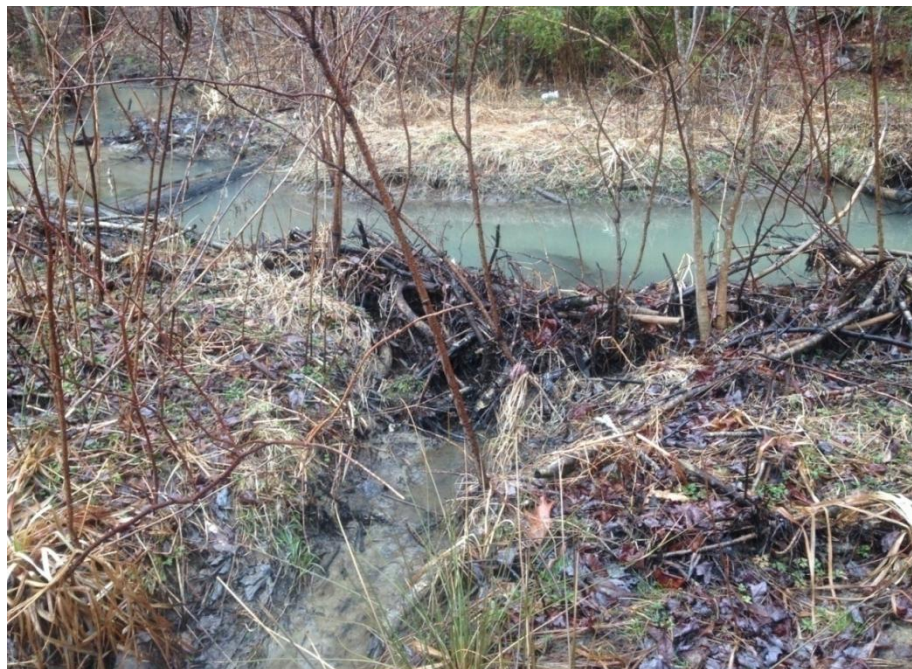
Check dams are small dams filling low areas in the terrain or otherwise diverting water to keep it within the main pond area. These were typically

between 1 and 3 m in the study sites; beyond that they generally joined and became part of the primary dam. Construction typically mirrors the primary dam, though being much smaller the base woody debris lattice constitutes a larger portion of the dam material. These dams are closely associated with anabranching channels in the downstream areas, as they are typically blocking outlets. These dams are sometimes submerged as the pond grows, leaving a consolidated woody debris/beaverlith conglomerate after abandonment.

Figure 10. Typical Check Dam. (Author)

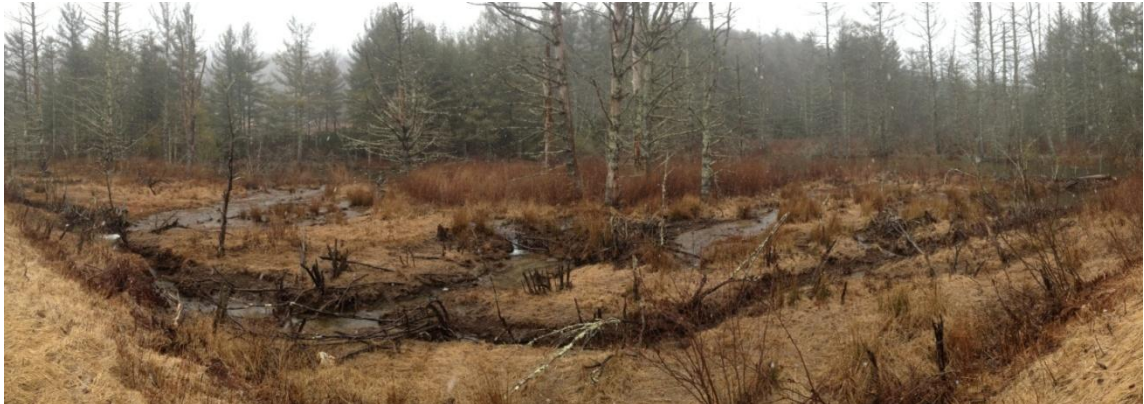
Anabranches were considered to be an stream channel running separately from the main channel for at least 5m, or where a main channel was

absent and flow divided into two or more smaller channels. Only channels with active waterflow were considered; ephemeral channels were disregarded for this study.

Figure 11. Meadow with Anabranching Channels. (Author)

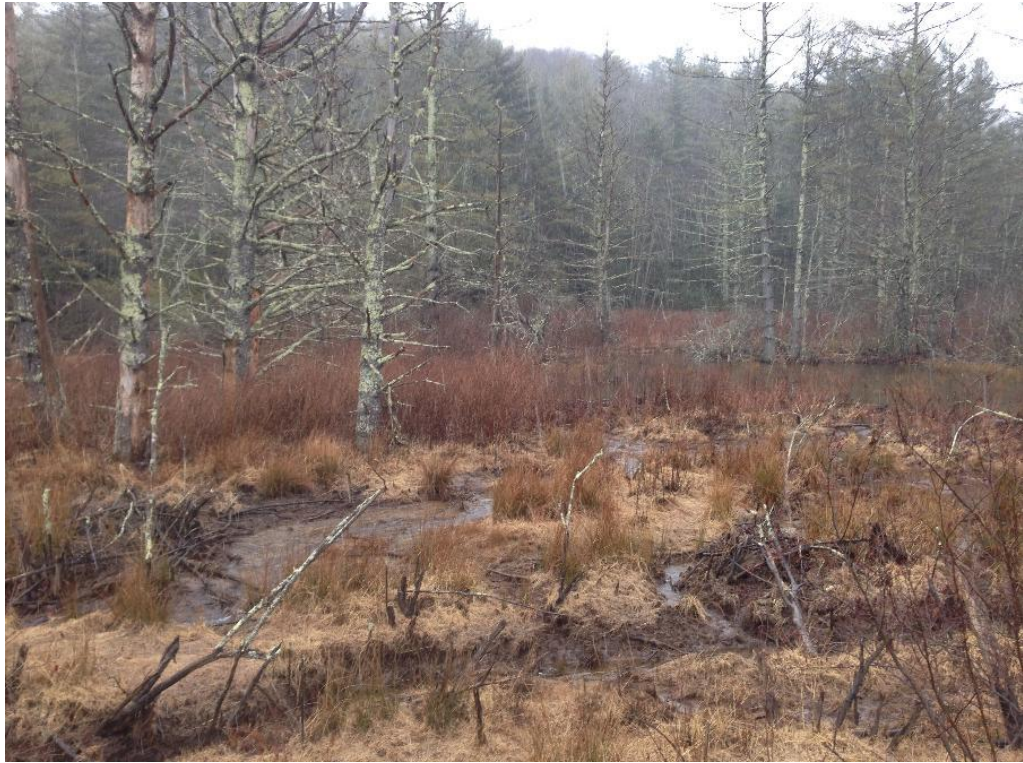
Figure 12. Woody Debris Piles – One on Bottom Right, one on Bottom Left.
(Author)

much of the woody material, it did identify concentrations throughout the pond area. Active ponds were certainly undercounted, as there was no practical method to survey the entire pond bottom when covered with turbid water. As the method of counting visible piles was applicable to all sites, it did provide consistency across all study sites. In abandoned or drained sites such as M3, examination of the pond area revealed much higher volumes of wood and indicates that substantial woody material is present in most ponds. Of particular interest to this study is the tendency of woody material of all sizes to become embedded in the bottom, through either beaver activity or sedimentation, and thus remain a long-term feature of the later beaver meadow, with implications for affecting later channel development through the meadow.

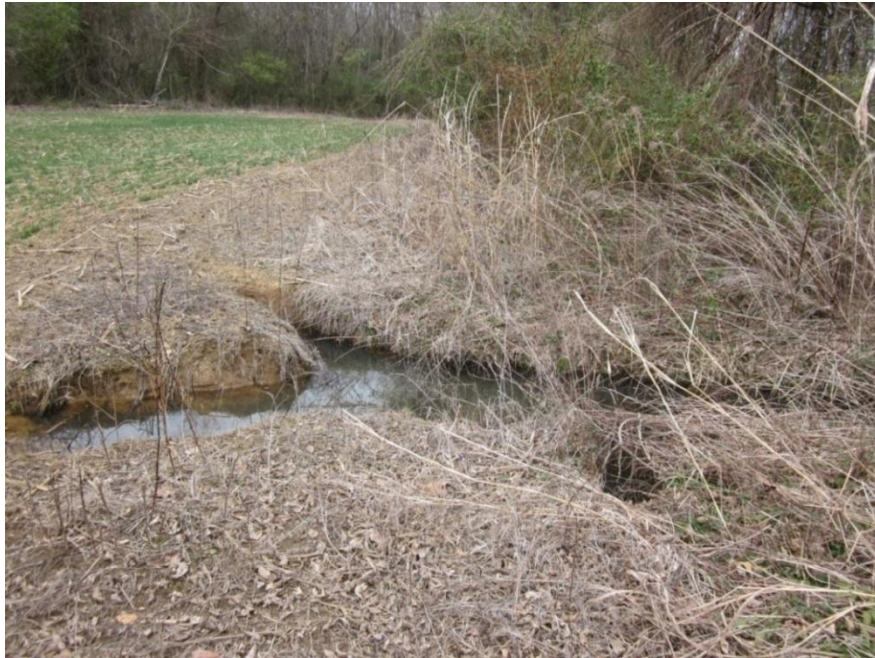
Beaver may sometime excavate canals to food sources not yet reached by the pond. Typically, these are approximately 1 m wide and .5 m deep, though this varies. As the pond grows, these become submerged trenches, and the canal may be continued further into dry land. Figure 12 demonstrates a canal heading into an agricultural field, figure C2 shows a canal in a partially inundated area. These canals may have a later influence on the beaver meadow and stream channel formation, and provide a ready path for erosion when a pond is abandoned.

Figure 13. Branched Canal in Agricultural Field. (Author)

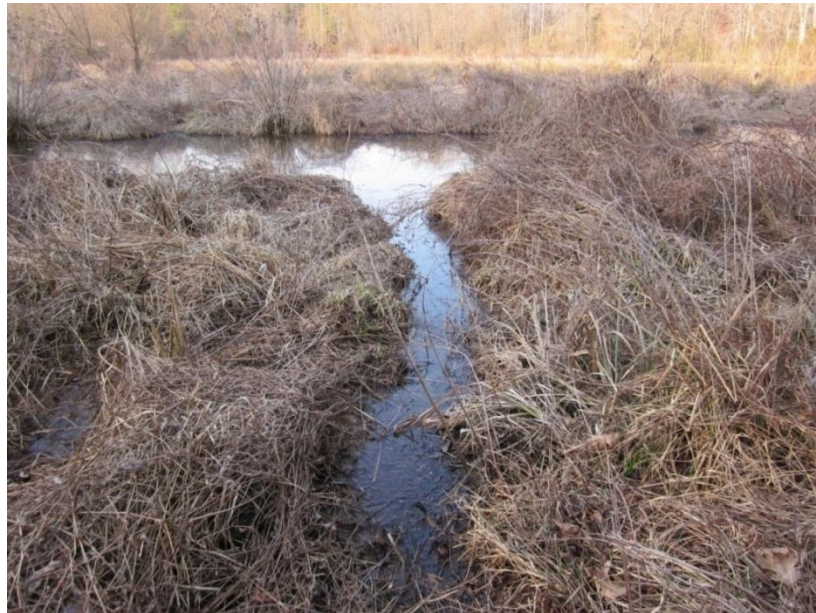
Figure 14. Typical Canal. (Author)

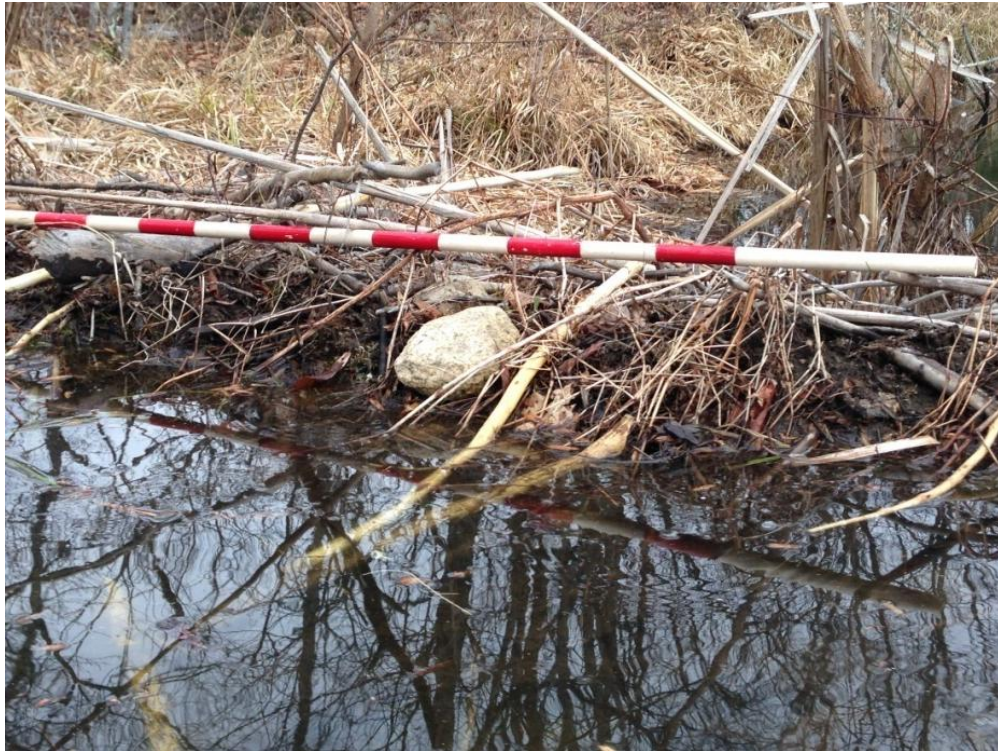
Figure 22. Stone Moved into Dam by Beaver; approximately 19cm x 15cm x 14cm. (Author)

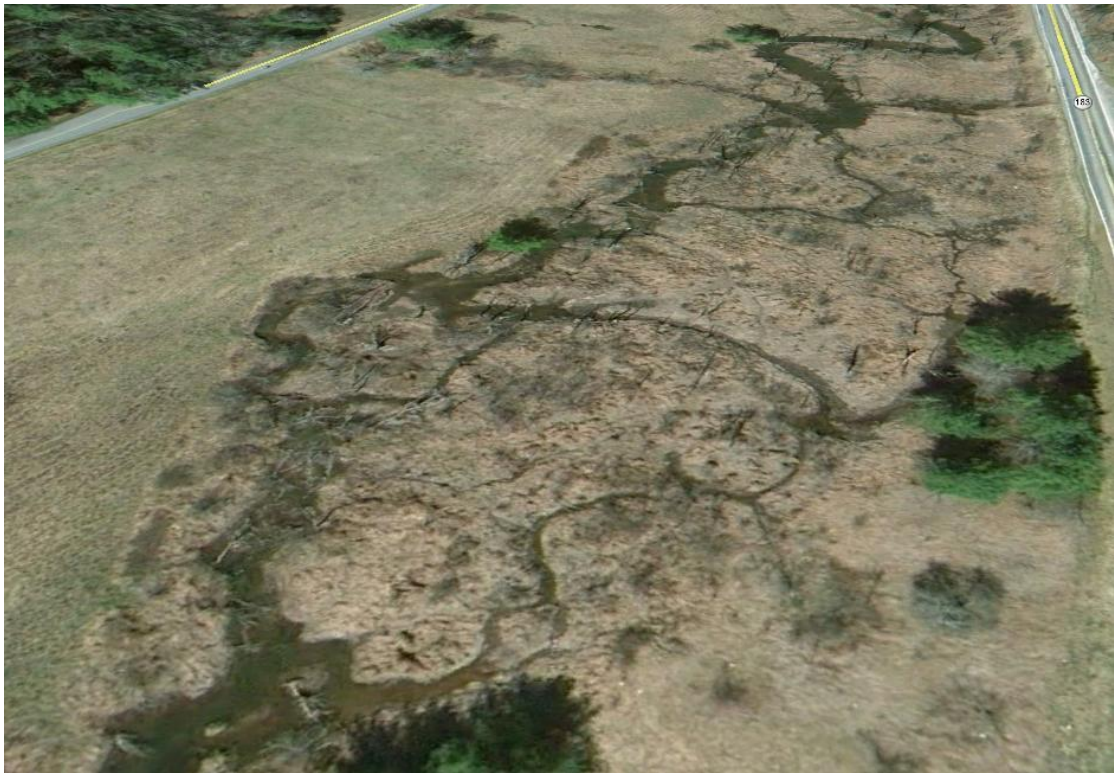
Figure 23. Anabranches in Abandoned Pond Area, Site M3. (Google Earth)

contain the beaver-generated woody materials, and have the additional influence of multiple water outlets from the upstream dam, creating a forced anabranching; these channels in turn are influenced by the various features noted above. In sites M3, M4, P1, P2, and P3, this was indeed the case as anabranching associated with both abandoned ponds (figure 23) as well as downstream of, or between, active dams such as site P3 (figures 24, 25) was documented.

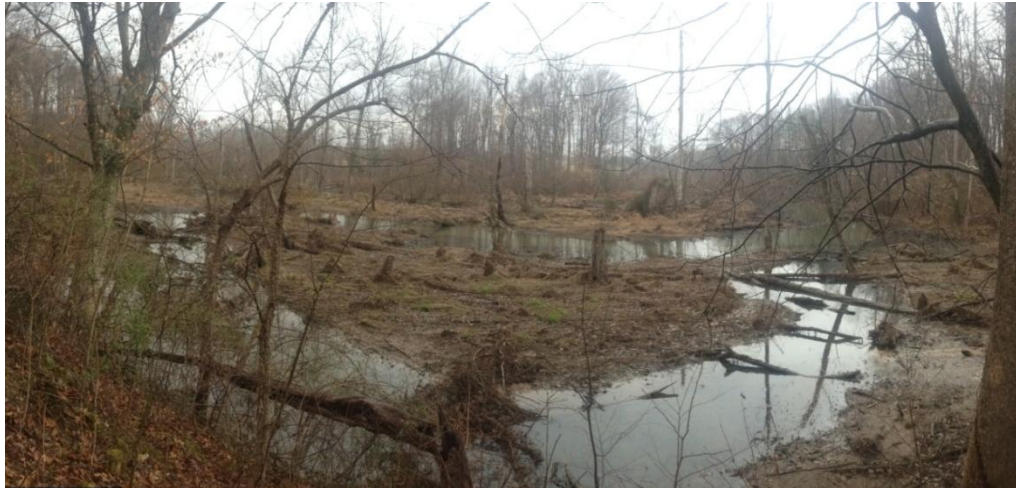
Figure 24. Anabranching at Site P3. (Author)

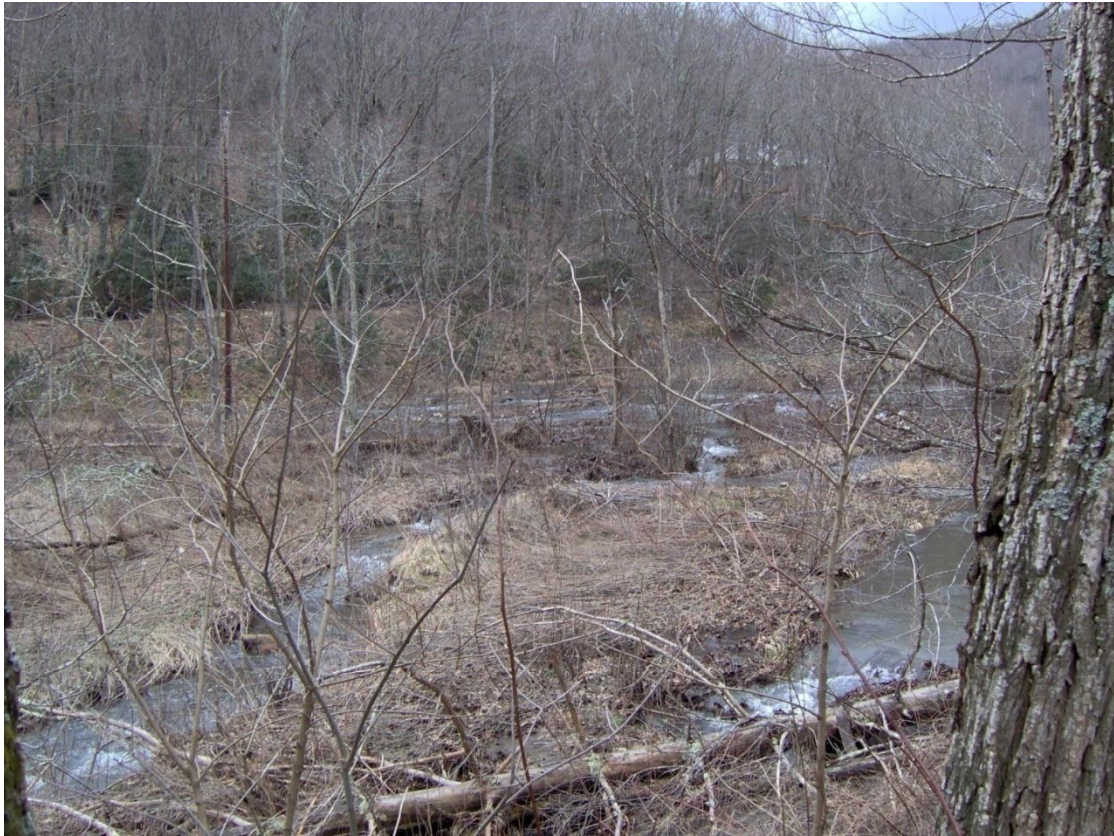
Figure A2. Pine Orchard Creek site, Downstream of the Downstream Dam during a High Stream Flow. The High Flow Illustrates the many Small Channels that have been created by Dam Leakage over a 5 year period. (March, 2010) (Author)

Observations over the 4 year study period indicated a dynamic system of stream outlets emanating from the three main channel dams, with the most downstream dam evincing the most dramatic changes as the stream left the confines of the dammed area and formed multiple channels over a 30 meter distance before finally rejoining into a single channel.

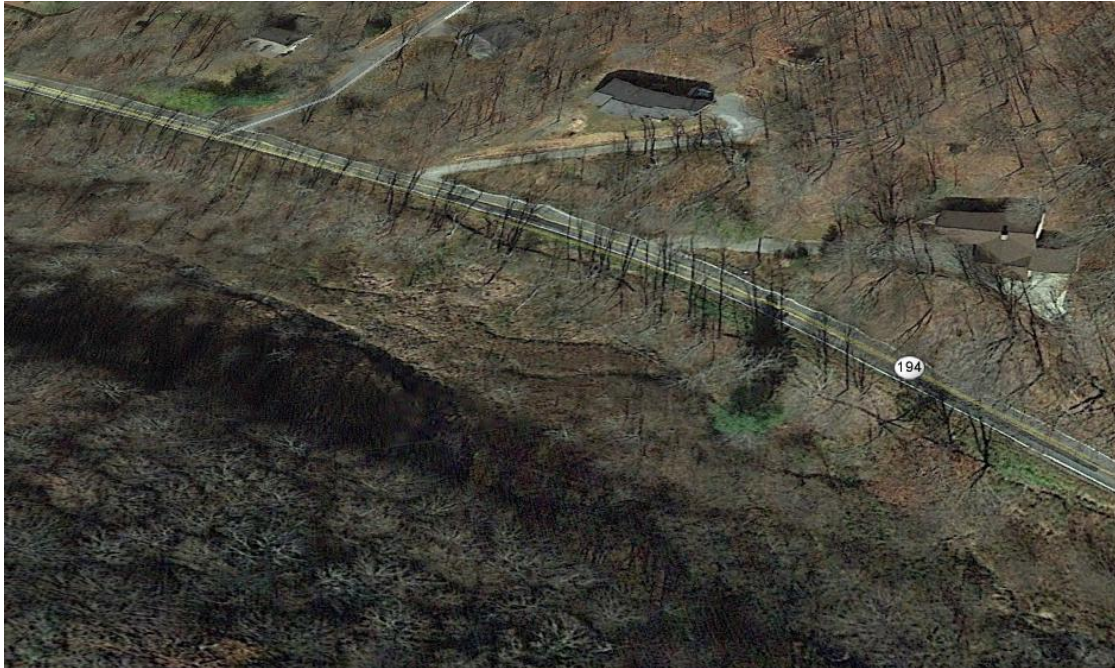
Figure A3. 2014 Aerial Photograph of the Former Beaver Dam Site on Pine Orchard Creek, Showing the Remnant Beaver Meadow and Remaining Secondary Branches. (Google maps, 2014.)

However, as figure PO3 shows, multiple side branches continue to exist, with at least three carrying water at all times and 5 more carrying water during high flow events.

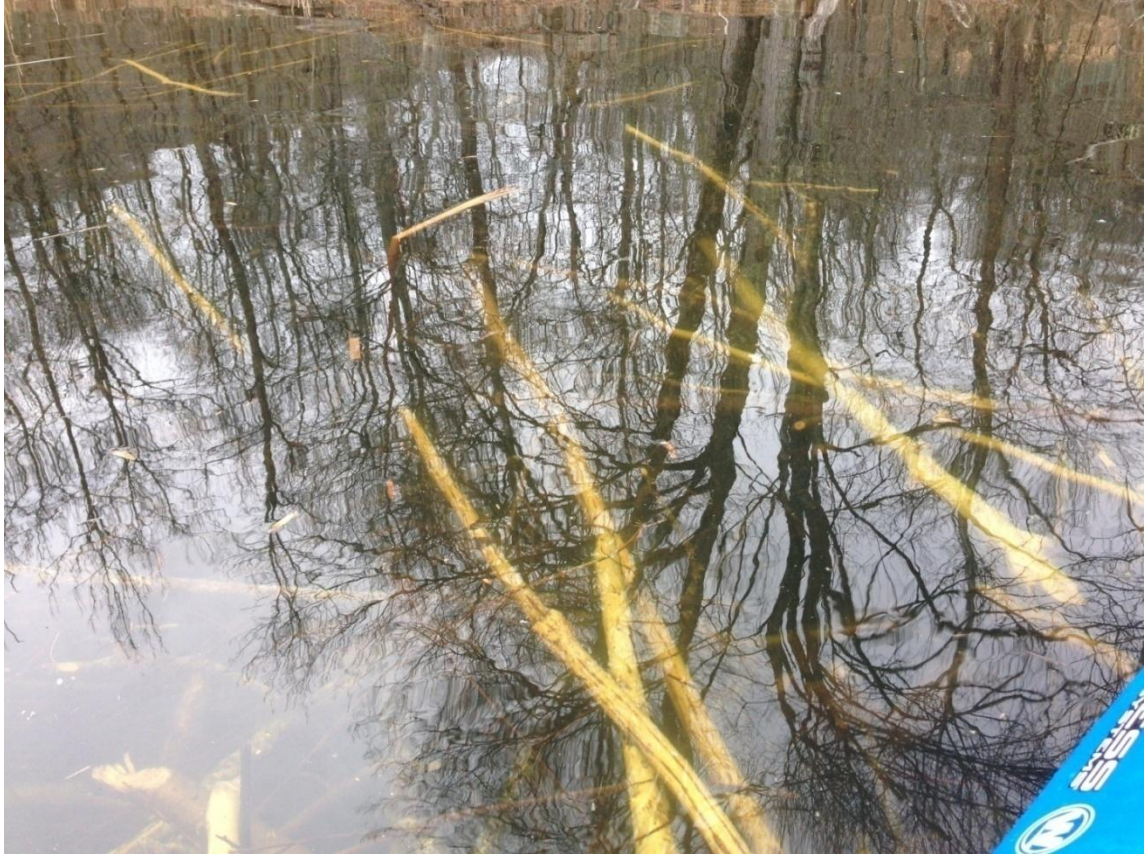
Figure A5. Food Discard Woody Material, approximately 1.5 m Deep at this Point. (Author)

indicates that these structures may become long-lasting features of the microterrain of beaver ponds and later beaver meadows.

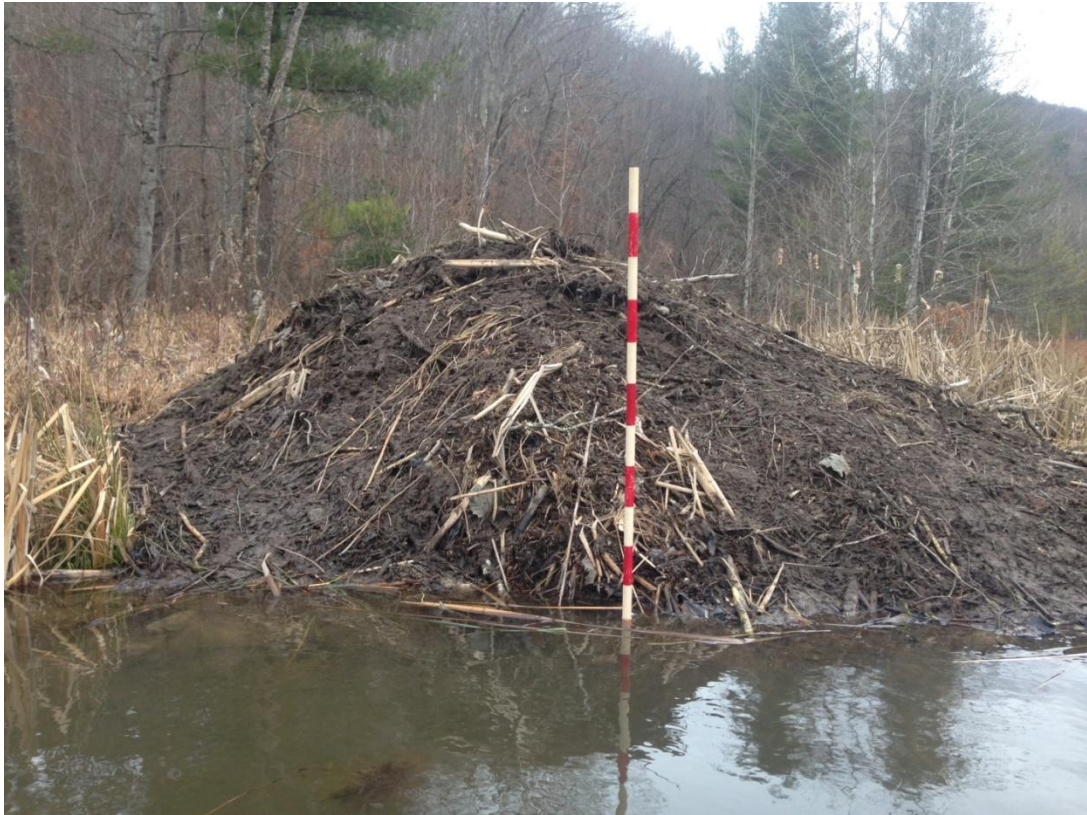
Figure A6. Beaver Lodge. Approximately 1 m above Water Level with .8m Submerged. (Author)

The second item of note in this pond is the development of a large lodge (figure A6.) This lodge is built against the edge of the former topsoil relocation area, and limited investigation (as it is an active lodge) indicated a primarily earthen construction with <10cm woody material and herbaceous materials forming a fibrous structure. The lodge is 3.5m wide, 6m long, and approximately 1.8 m tall, forming a substantial structure with potential for long term retention of the materials contained within its construction. Probing depth around the lodge indicated two channels leading into it, both approximately .5m deeper than the surrounding water, which may also continue to influence the microterrain of the area after abandonment.

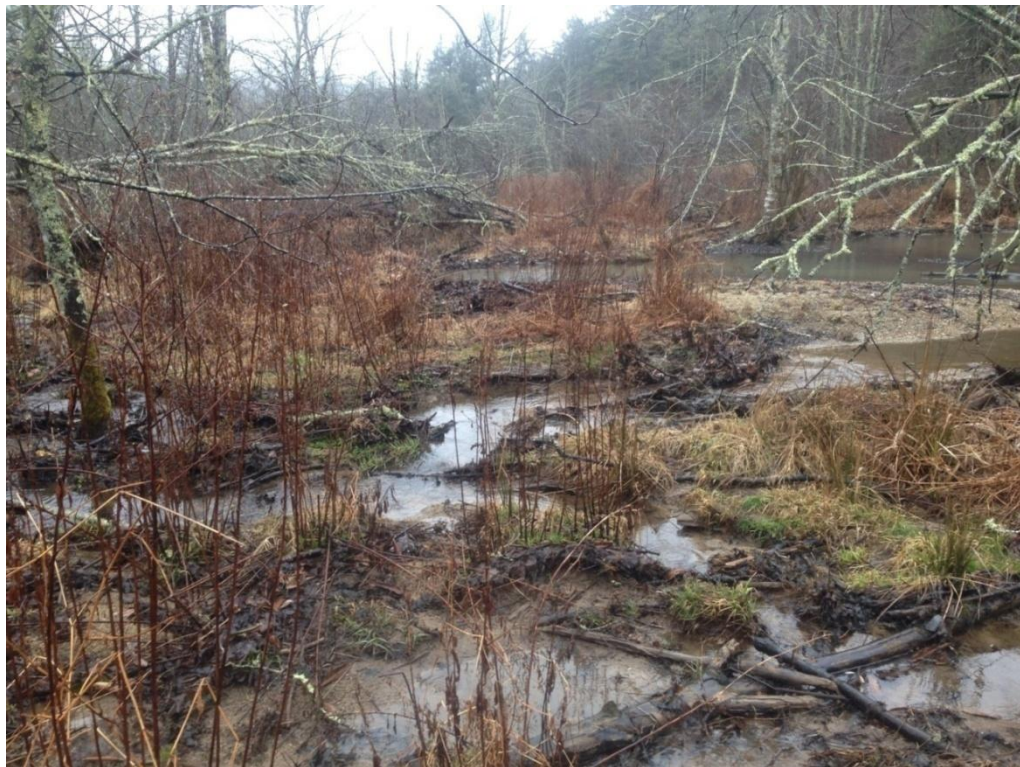
The uppermost area of activity in the Camp Creek Complex, damming has created a large (2 hectare+) meadow of anabranching streams (figure A8, A9), ephemeral channels (figure A10), and small check dams (figure A11), with a large quantity of both standing and fallen woody material.

Figure A8. Upper Camp Creek Complex. (Author)

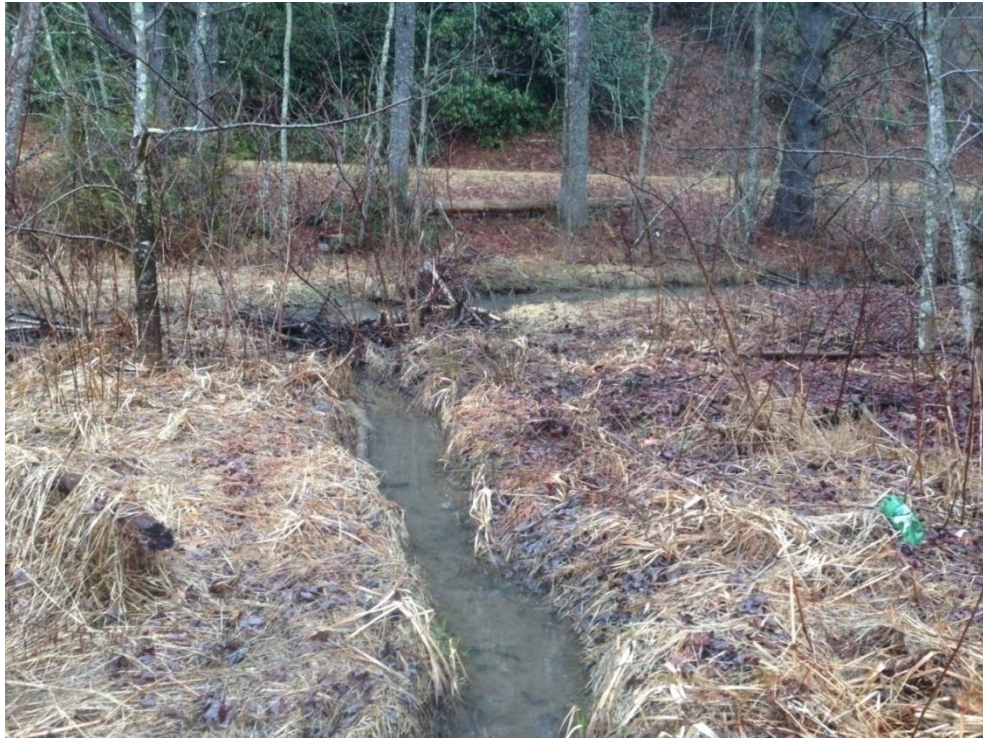
Figure A9. Upper Camp Creek Complex, Branching Channel, likely formed from an earlier Beaver Canal. (Author)

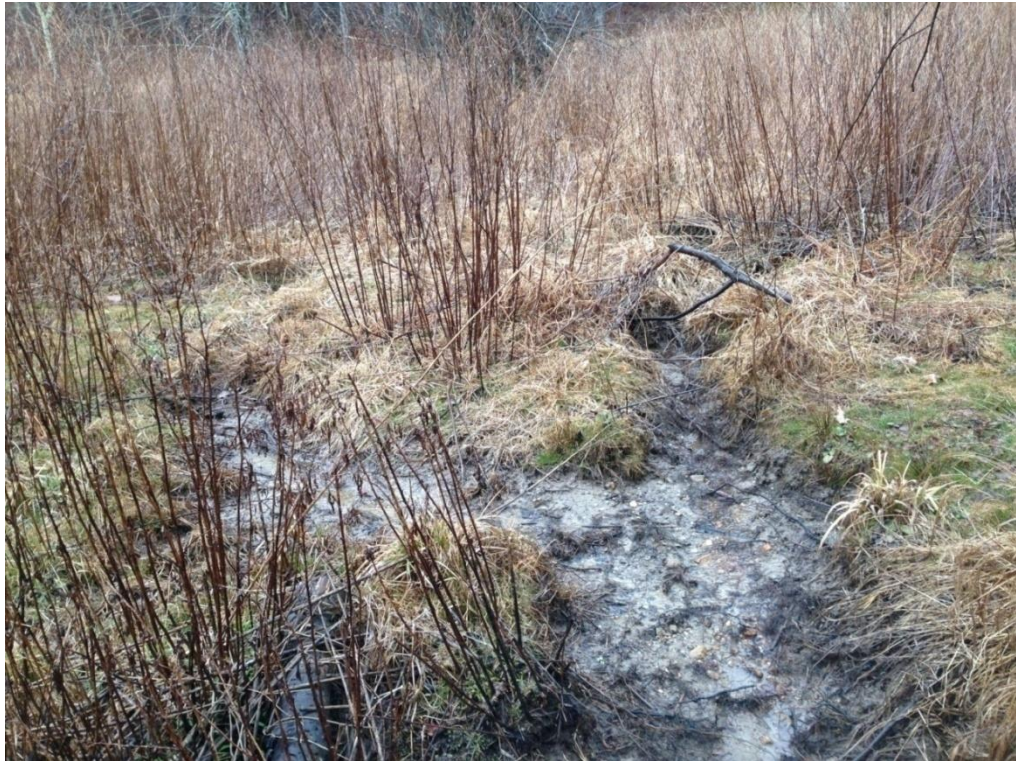
Figure A10. Upper Camp Creek Complex, Ephemeral Channel. (Author)

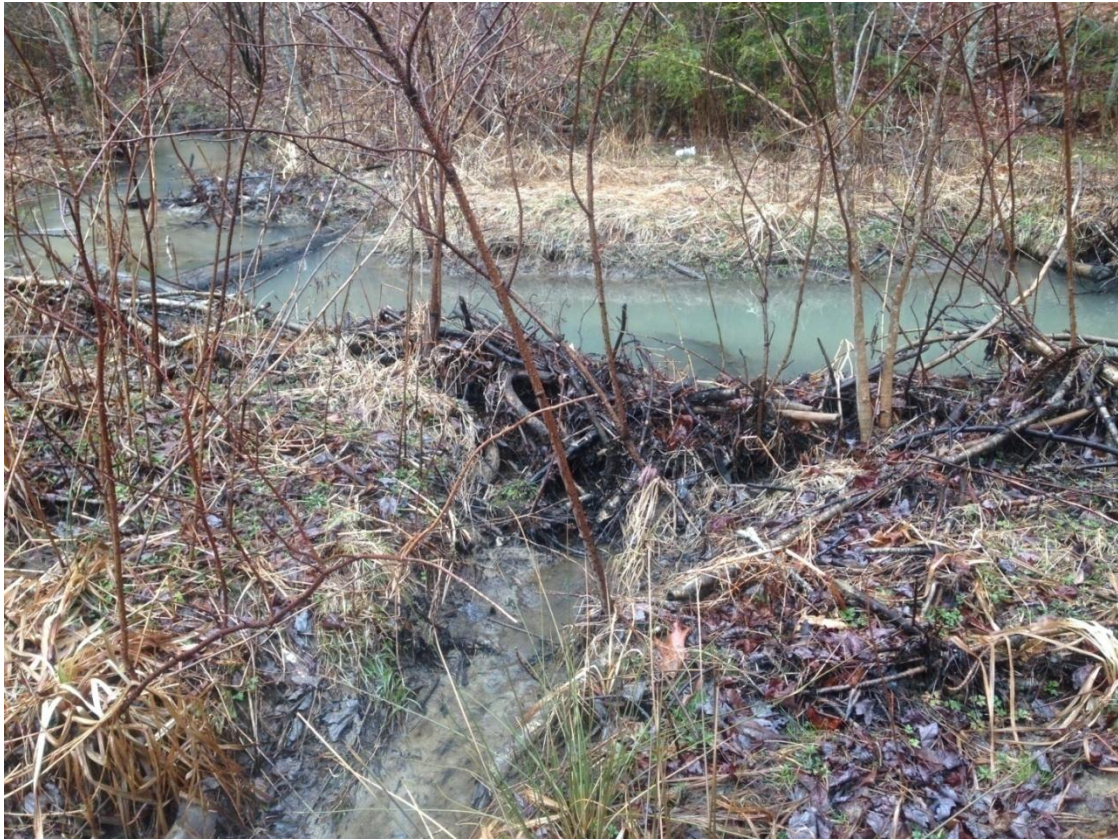
Figure A11. Upper Camp Creek Complex, Check Dam. (Author)

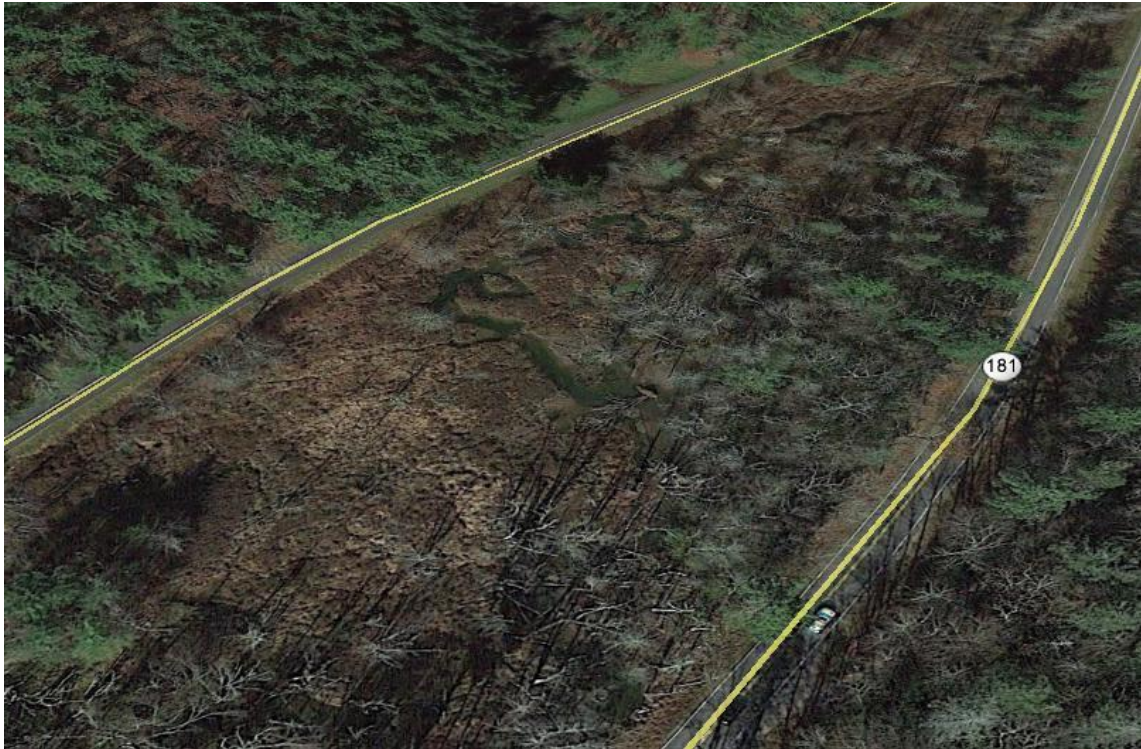
Figure A13. 2013 Aerial Photograph of Site M3 Upper Reach. (Google Earth)

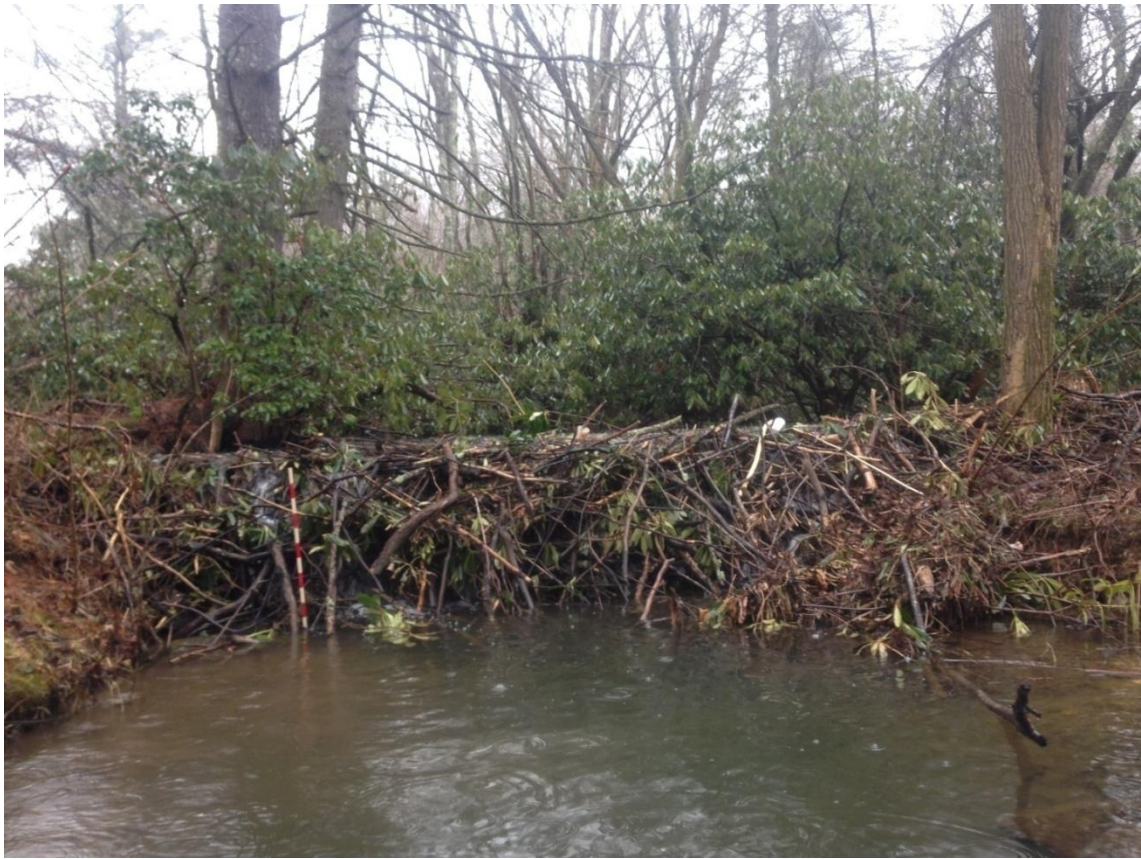
Figure A14. Rhododendron Dam. (Author)

Of note at the lower end of this reach is a dam constructed of wattle and daub style, but the woody material is almost entirely rhododendron (*Rhododendron* sp.) (Figure A14.) This dam was constructed in the summer of 2013 and sporadically maintained until all beaver activity ceased in 2014, flooding a small $<500\text{m}^2$ area. No rhododendron bark was eaten, and only small amounts of hardwood food trees were reached by this effort. No lodge was found in this area.

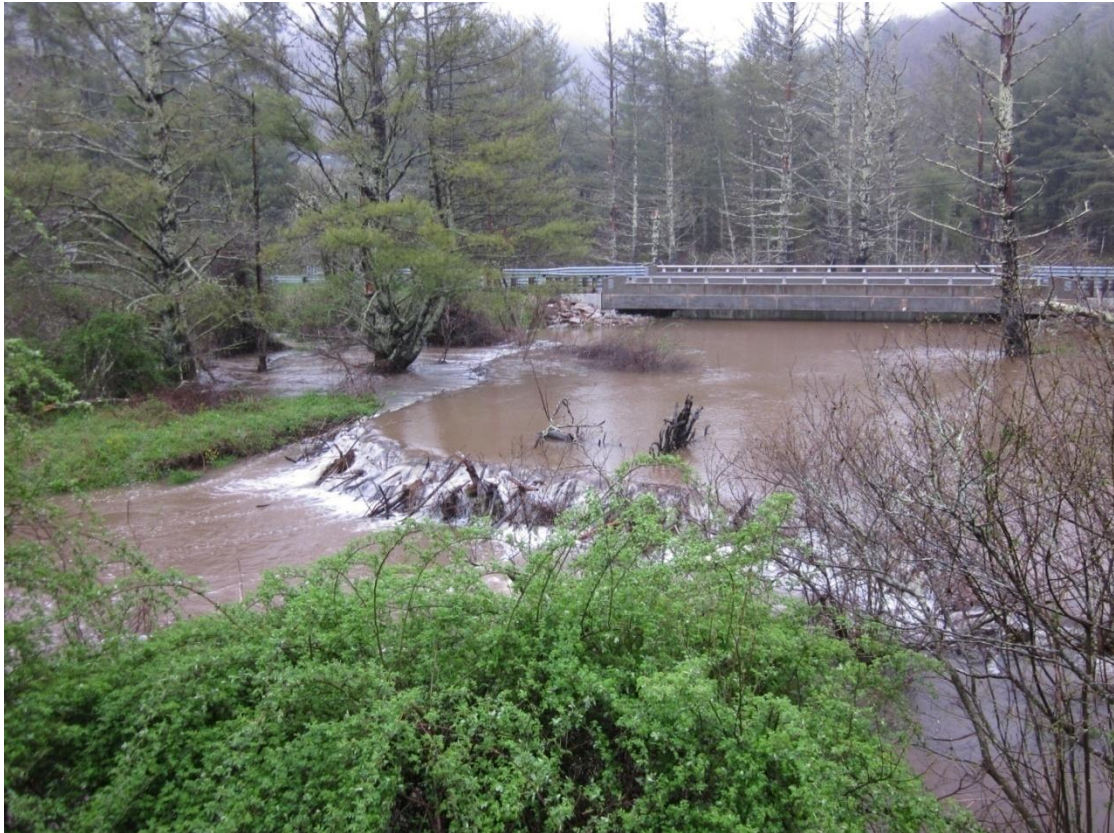
Figure A15. Camp Creek, Dam below Donald Barrier Street before Breaching. May, 2013, during a high flow event. Note large rootwad in center. (Author)

In the middle section of the reach one dam near a bridge has been breached several times due to threats to the bridge. According to nearby landowners, the dam (just downstream of Donald Barrier Street) was breached sometime in the 2008-2009 time frame, and during the study period, the dam (Figures A15, A16) was breached in 2013 (though rebuilt within 5 months), and breached again in summer 2014 and has not been rebuilt as of this writing. The dam below Parkway Road was breached in 2013, and has not been rebuilt.

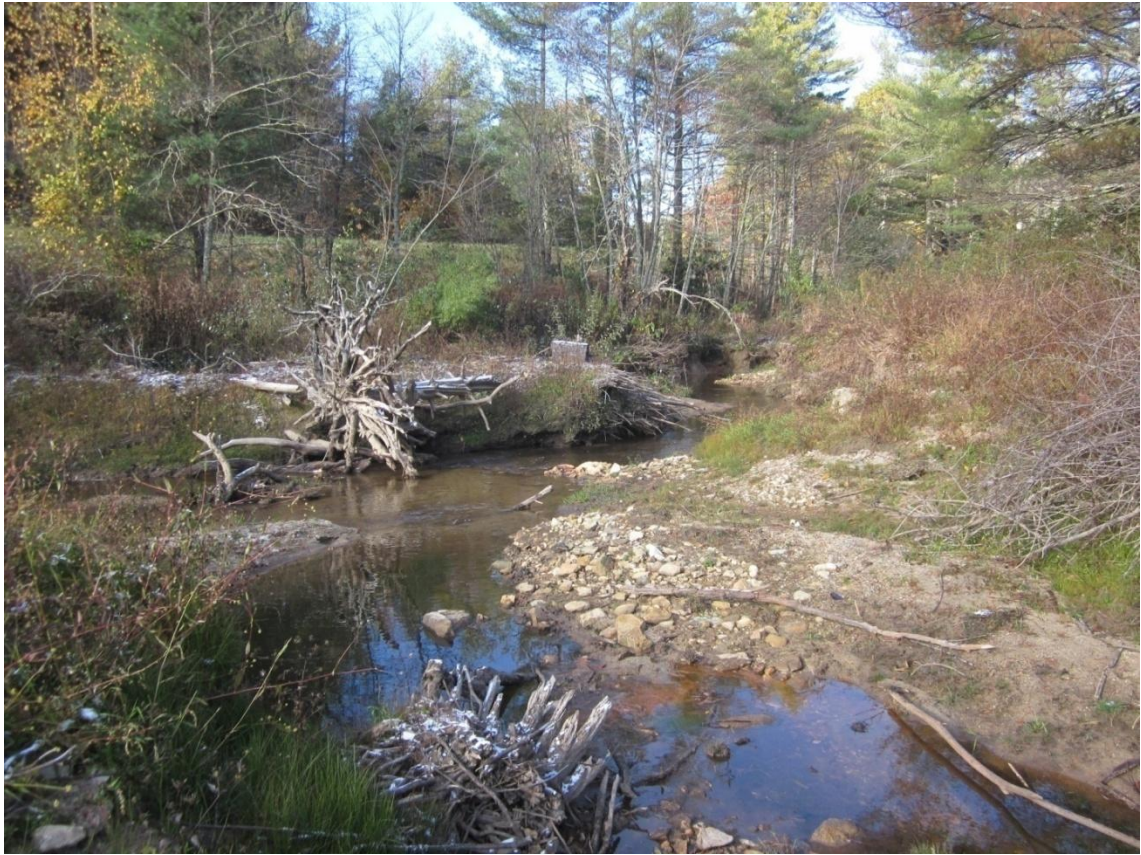
Figure A16. Camp Creek, taken from Bridge in Figure A15, after Breaching. Note large Rootwad, the tip of which is visible in Figure A15, and which has been present in this location for 4 years. (Author)
